MEDISTONE

Preservation of ancient Mediterranean sites in terms of their ornamental and building stone

Newsletter n°3 January 2007

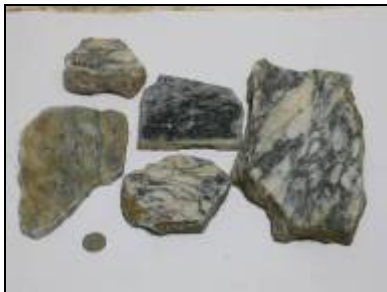
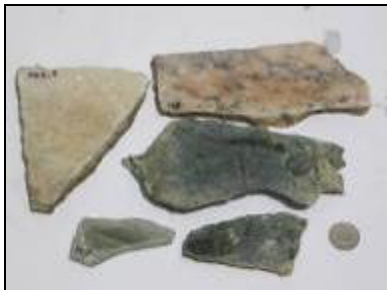
Photos 1 & 2

Concerning Volubilis, a first field campaign during May 2006 dealt with a visual description and identification of the main types of building stones (various limestones) and decorative stones (marbles *sensu largo*) and to collect representative samples for in-laboratory characterization (microscopic study of thin sections, X-ray diffraction, identification physical tests, isotopic analyses...). Parallel to Volubilis site investigations, a preliminary search for ancient quarries that could have supplied the site with stones began in surrounding area. Different quarries were located, visited and sampled. According to decorative stones, all the excavated areas have been carefully explored for the presence of stones different from local ones and of true marbles. Each single house and the most important monuments have then been inspected and selected fragments of the mentioned stone materials taken for analysis. In general, from what has been observed in situ, a very limited amount of marble s.l. species has been noticed (Photos 1 and 2). To carry on study of decorative stones from Volubilis, a second mission during September 2006 on Volubilis and Rabat was performed to sample some white marble objects and column exposed at the present time in the archaeological museum of Rabat and some of the marble objects collected during the excavation and stocked in the storerooms of the conservation of Volubilis. The search of traces of ancient quarries by the mean of a detailed study of geological data available and of a systematic exploration of Volubilis region outcrops was also carried out during the first period of the project. All these preliminary visual results concerning both building and decorative stones of Volubilis have to be confirmed and achieved by the in-laboratory analyses still in progress.

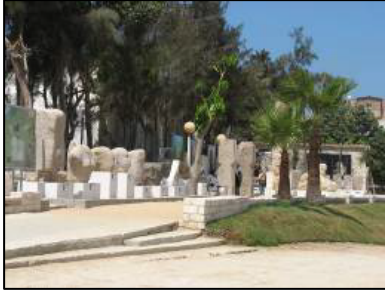
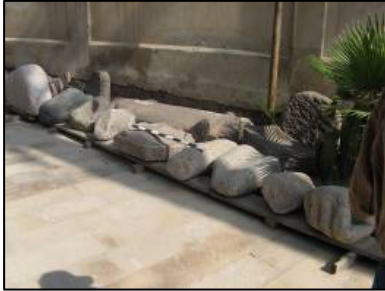
Photos 3 & 4

In the framework of MEDISTONE, a first field campaign during July 2006 permitted to visit QaitBay fortress (supposed to be built in the place of the collapsed lighthouse and using its ruins) and to proceed to an overall examination of the different sites of storage / exposure / exhibition of the lifted out blocks (cf. Photos 3 and 4). In general, the stones examined are present in a form of columns, part of columns, large blocks, small blocks, statues and obelisks. They are formed either of rose granite, granodiorite, marble (rare), recrystallized limestone, graywacke, quartzite and silicified sandstone. During a second campaign in September 2006, a detailed study of the blocks exposed in the previous selected sites was carried out with the aim to inventory the main types of the building and the ornamental stones related to the lighthouse. In addition, most of the blocks were sampled for in-laboratory characterisation (petrography, mineralogy, chemical characterisation, identification of physical properties and isotopic analysis) still in progress. Parallel to the study of building and ornamental stone blocks exposed in Alexandria, the search of ancient quarries began with the study of al-Max – Abu-Sir area (western Alexandria) indicated in a previous work as quarries used for the lighthouse construction. “Old” and “modern” quarries of both of the sites were visited and sampled. As most of the stone related to the lighthouse are still existing underwater and thus not easily available for study. Cooperation between the MEDISTONE team and the archaeologist of Centre d’Etudes Alexandrines took place, and resulted by providing for the present study many samples collected from the stone blocks existing underwater site, during their diving season in September & October 2006. The collected samples from the stone blocks in different sites at Alexandria as well as those collected from the underwater sites were sent to European Partners at the end of 2006 for In-laboratory characterisation still in progress.

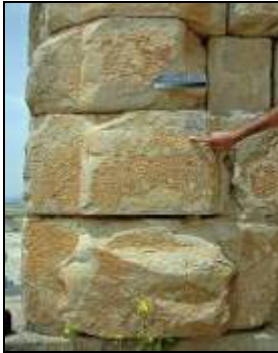
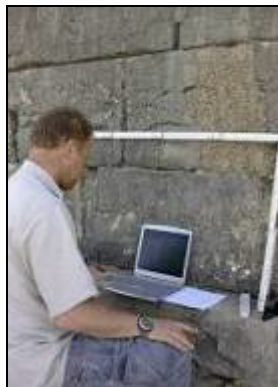
Photos 5 and 6

According to Volubilis, the work began with a bibliographic research on the site and its environment undertaken. Then, during the mission of May a detailed survey of the site listed the various degradation features on the different types of stone recognised by the WP1 group. Photos were taken at different scales in order to make the guide of main degradation features. Three main active different natural degradations were observed : a thin desquamation phenomena affecting the grey and hard building limestone, a granular disintegration affecting the yellow and soft limestone and an orange patina visible on many walls and sculptures of the site (cf. photo 5). Consequently, it was decided to focus in-laboratory research work on two main topics :

A part of the north wall of the basilica of around 20m² was selected as representative area for the mapping (cf. photo 6) and the description of the degradation features. Two grey hard limestone stones of this wall showing fissures were selected for both WP3 restoration work (reassembling) and degradation features mapping at the scale 1/2. A pillar of a gate in a villa built with the soft yellow limestone, showing desquamation, granular disintegration and fissures was also selected and mapped (1/5) for deeper investigations in relation with the work of the WP3 (reassembling). The general map is now available and documented with more than 60 different degradation patterns. Twenty samples (powder, scales...) were also collected for In-laboratory analyses in progress.

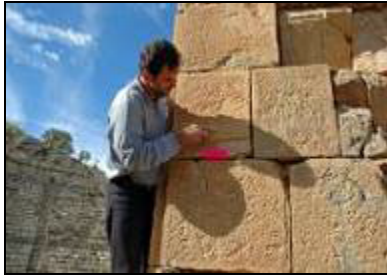
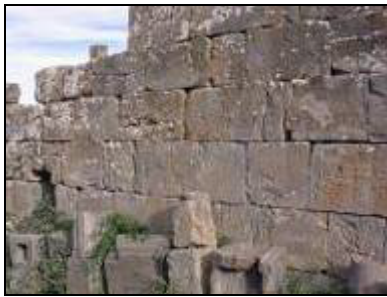
Photos 7 and 8

Concerning **Djemila**, a detail survey of the site was undertaken during the field mission of November 2006 to list the various degradation features. Views were taken at different scales in order to make the guide of main degradation features. The in situ study showed that fracturation, orange patina and lichen colonization were the main degradation patterns affecting the stones. Deeper investigations were done on the site in order to describe more precisely the degradation features and to collect samples (powder, scales, lichens ; analysis in progress):

- Lichens were mainly collected in the theatre which presented all the different kind of species
- The orange patina (cf. photo 7) was also studied and sampled in the theatre; this degradation pattern is very interesting because also present in Volubilis site;
- Two zones of around 20m² (an arch that threatens to collapse and a West wall along the rebuilt temple of Septimius Severe ; cf. photo 8) representative of the fracturation affecting limestones were selected, documented and sampled with the agreement of both WP2 and WP3 partners.

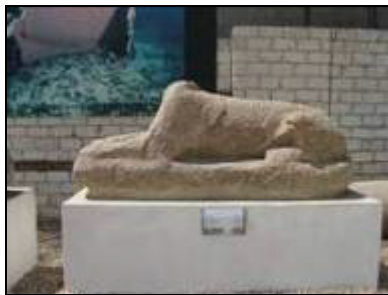
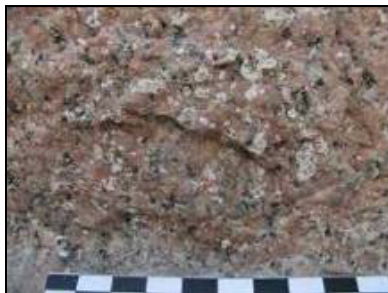
Photos 9 & 10

In **Alexandria**, 2 sphinx in exhibition at the open museum Kom El Dikka (near roman theatre) have been selected as preferential object case-study. They are respectively made by pink granite and a dark-compact granodiorite. The main damages of the sphinx granite-made is an exfoliation probably generated by salts re-activated during the out-door exhibition (cf. Photos 9 and 10). Many parts of the granodiorite sphinx are missing and the valorisation of this sculpture with blunting surfaces, don't need cracks filling/padding but a real re-assembling action. The sampling on these two original sculptures is not realistic, that's why the next field-work planned in March 2007 at the Aswan quarry will allow a sampling of their equivalent rocks to be tested in laboratory for adhesion and sealing products previous to sticking/pinning action.

For the filling restoration action, some re-assembling products have undergone lab preliminary evaluation tests. These tests were focalised in practical aspects (consistence, setting, hardening and fissuring) in order to adapt in-fine use of these products to the width of the fractures to be filled. The lime-based products are traditional, and could be made using the local lime to meet the demand during the application in site of the final research finding. The products to be used for the degraded sphinx are commonly used in the stones conservation: Ethyl silicate for superficial consolidation and sticking epoxy resin (some are available in Cairo) for pinning/sticking actions.
